Town of Niagara-On-The-Lake

King Street Investigation

GMBP File: 618025
Draft Submitted: March 2019
Revised: November 2019

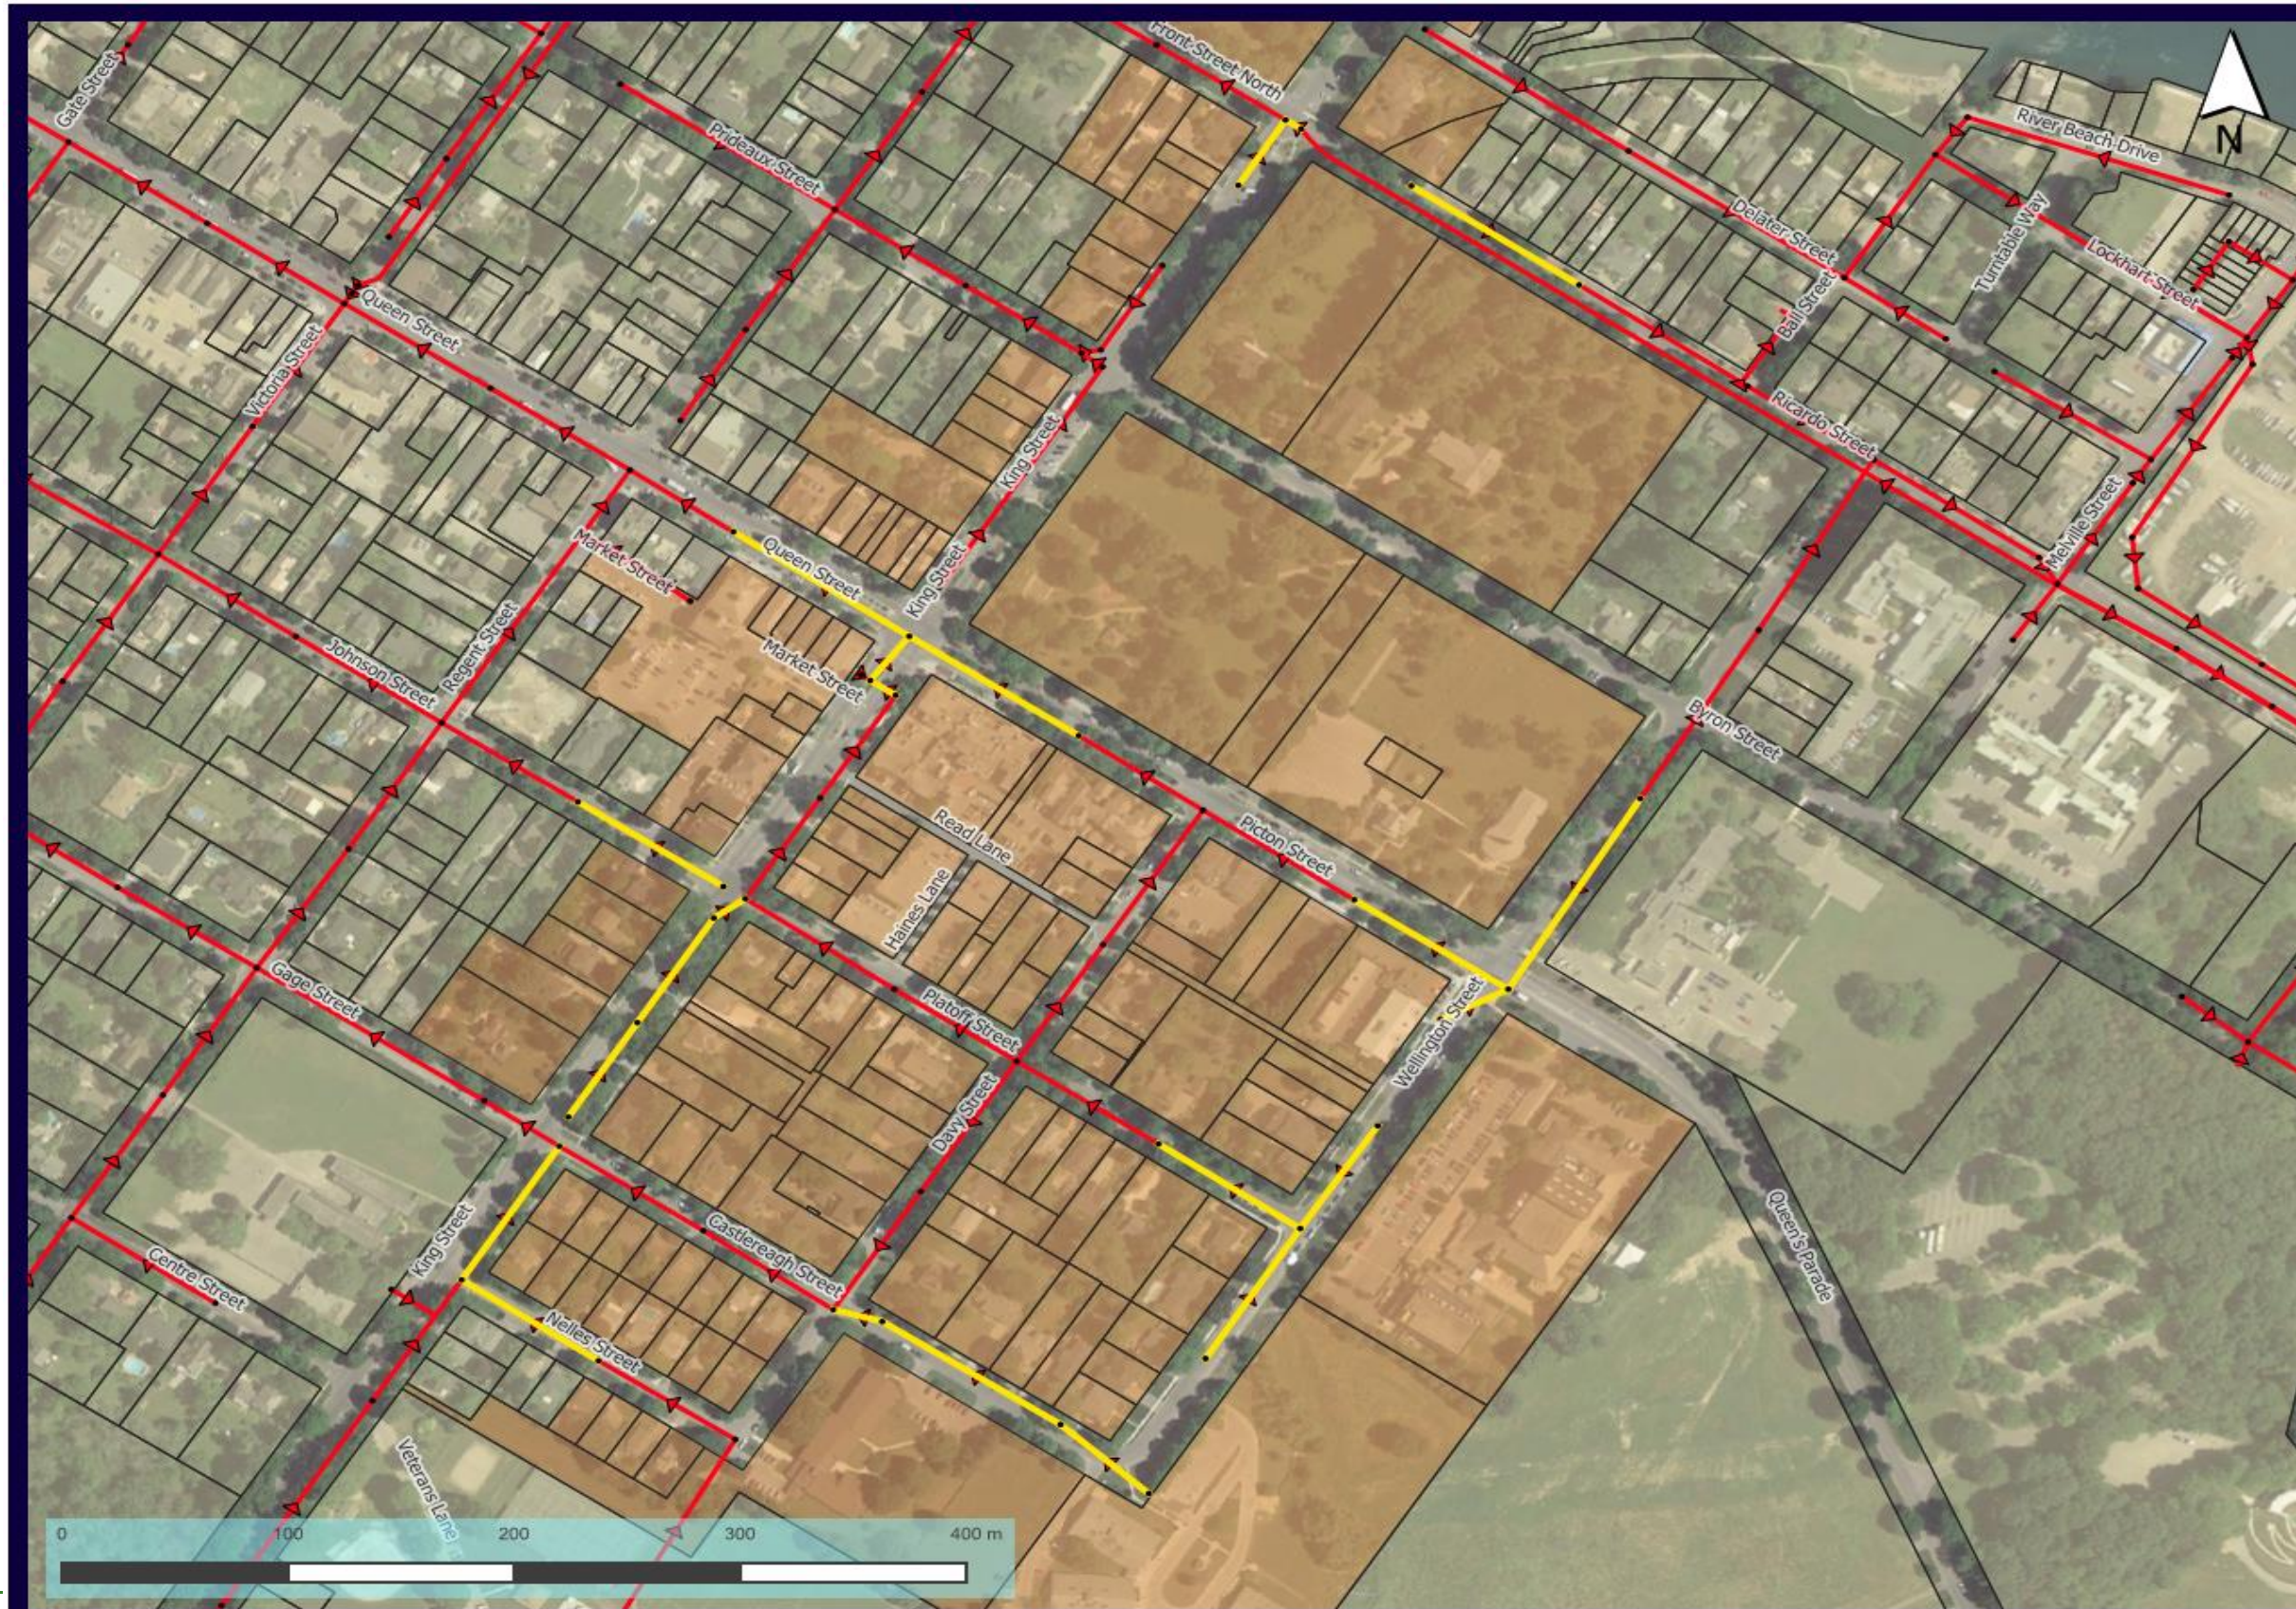
Study Area Pipe Review
Sanitary Sewers Without CCTV Review

6. GMBP has identified multiple sanitary pipes in the KSSO catchment area that do not have CCTV data (was not provided for GMBP review). **NOTL to confirm if CCTV data exists for these sanitary pipes and complete CCTV in areas (as required) and PACP defect condition assessment. GMBP estimates \$7,000 to CCTV if all data gaps exist.**

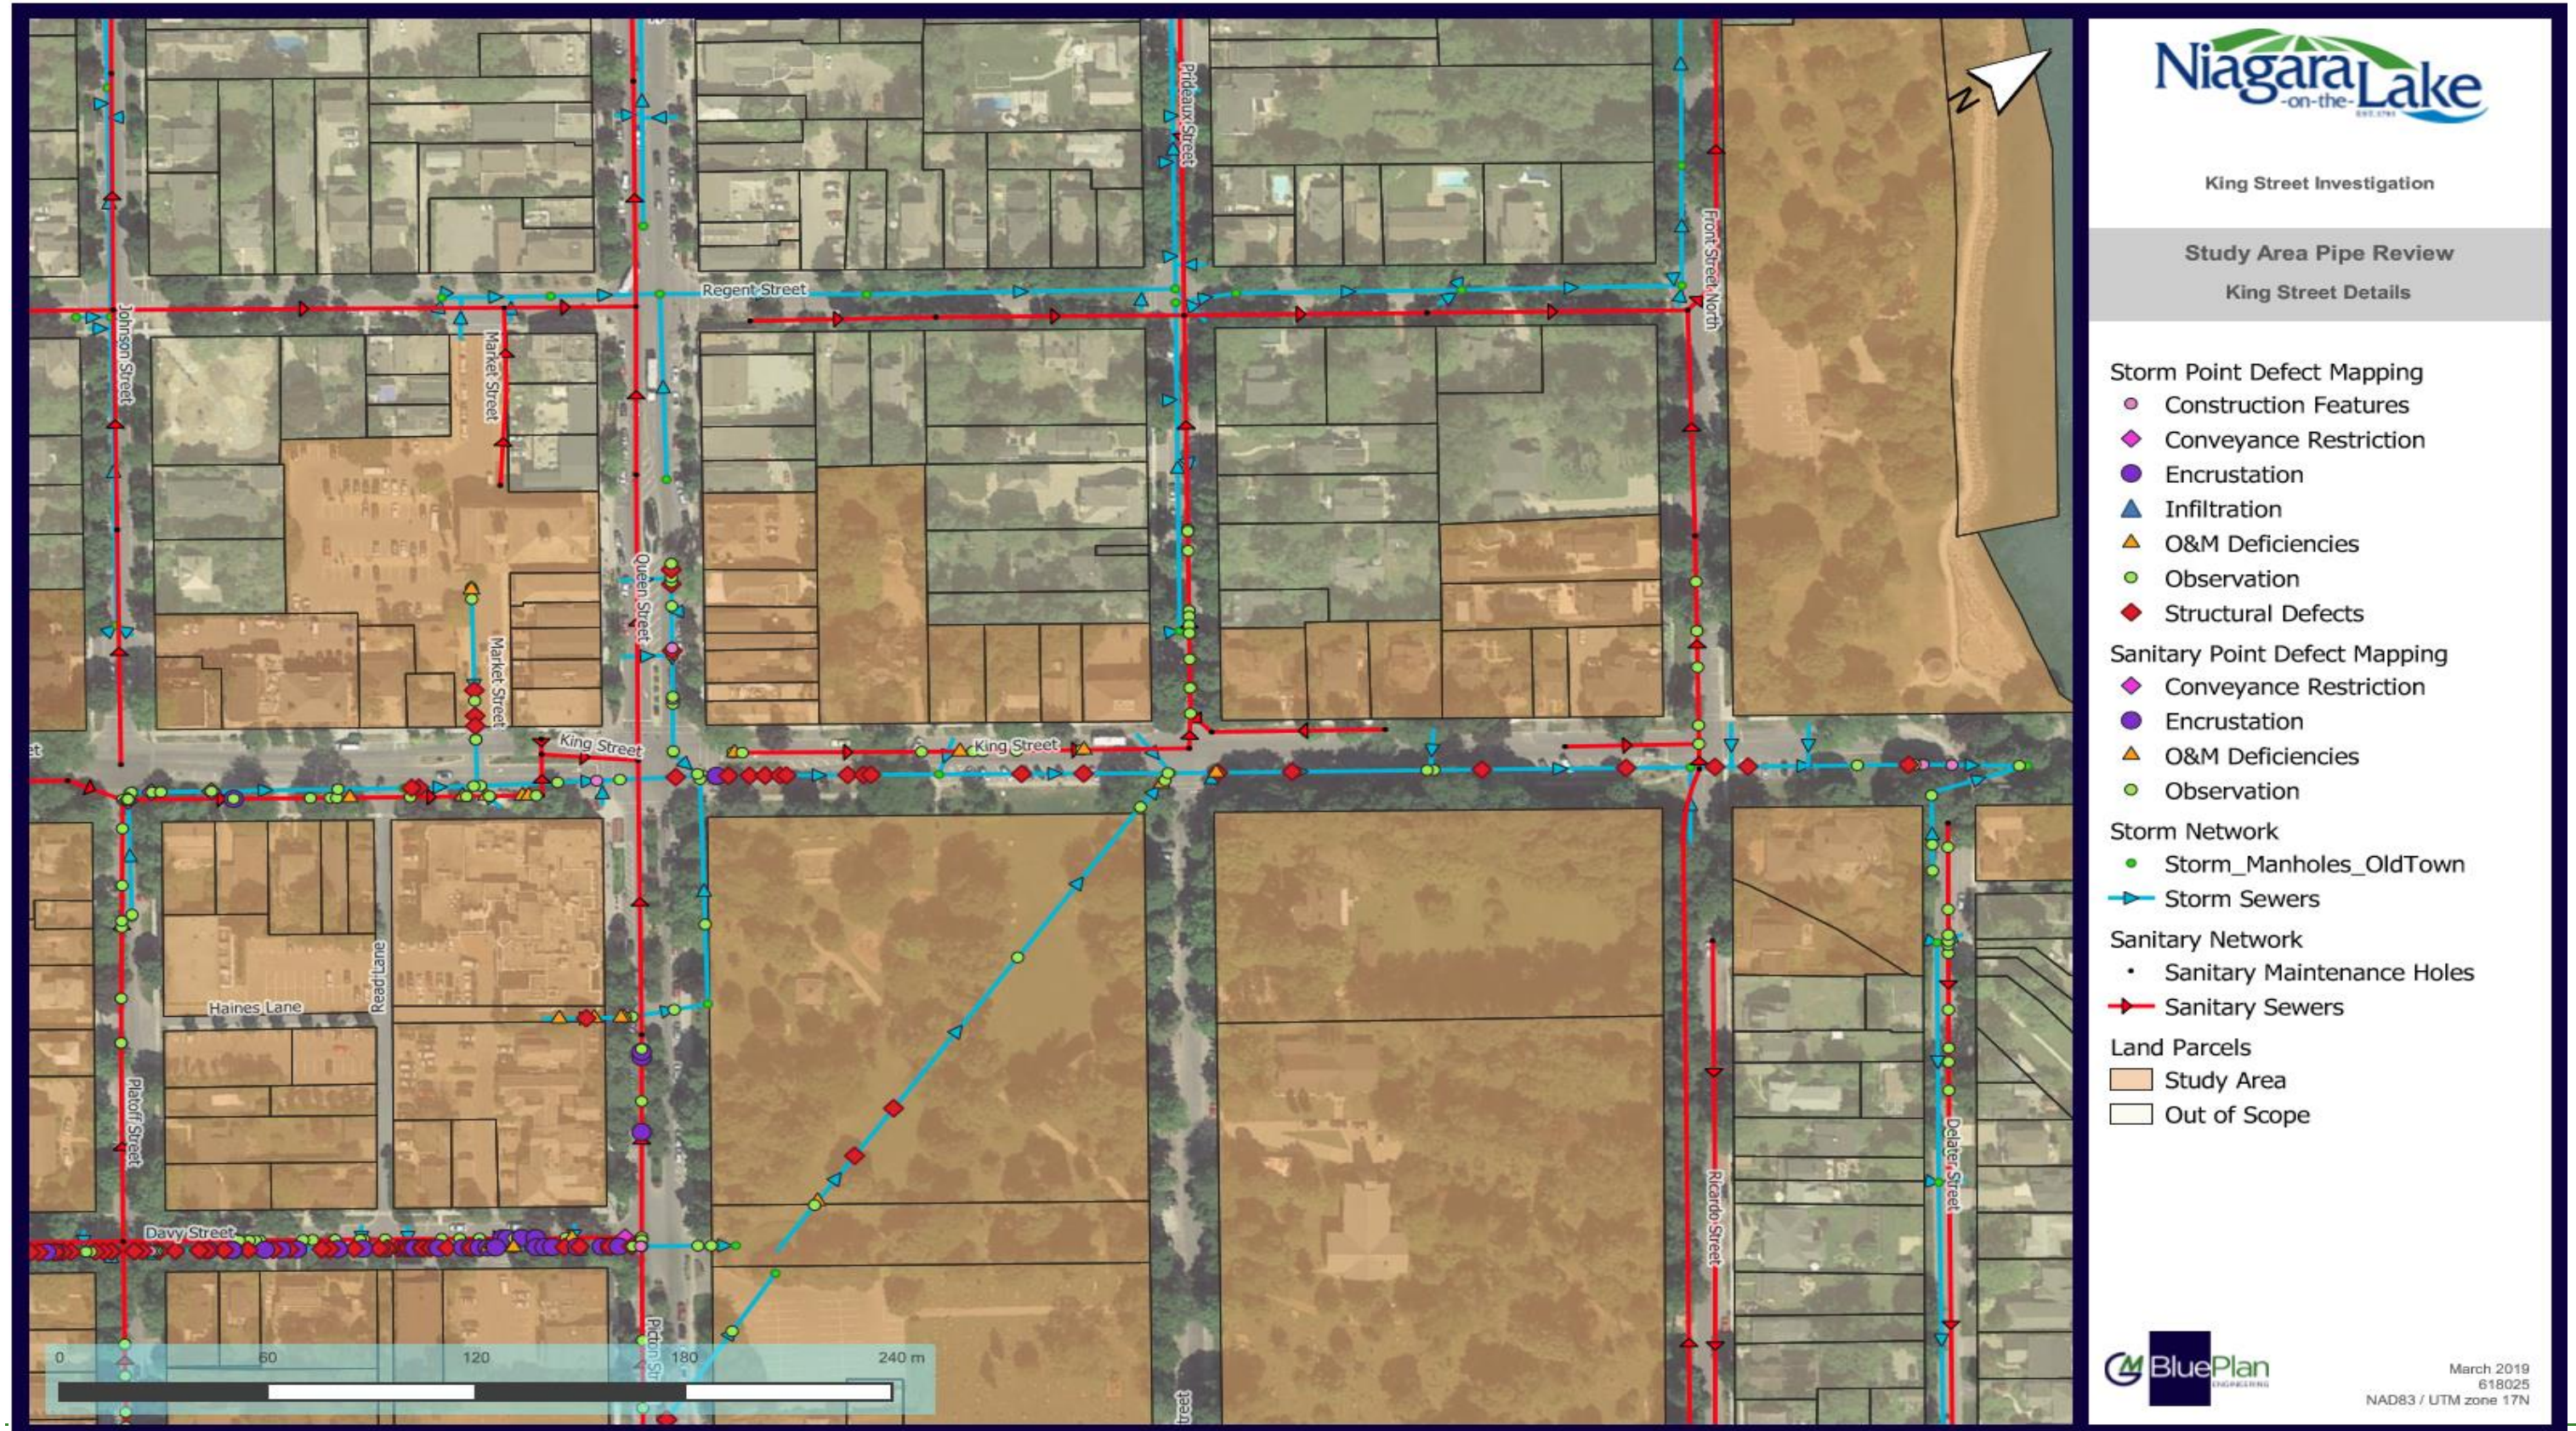
CCTV Storm & Sanitary Defect Photos

Results from the storm mainline CCTV review identified Davy Street as the worst condition storm sewer in the project area. Davy Street storm sewer includes multiple areas with cracks, fractures, groundwater infiltration, rebar exposed in majority of areas, defective taps, and broken pipe sections. The sanitary sewer on Davy Street is PVC which is in good condition, but an area does exist with encrustations (low flow leaks create encrustations) near Platoff Street.

King Street storm sewer was considered the second worst condition sewer pipe due to cracks, fractures, surface damage, rebar exposed, defective taps. The sanitary sewer review of King Street identified an area with large tree roots within the sanitary sewer near King Street and Platoff Street. It is interesting to note the King Street storm sewer is a concrete pipe but has sections of PVC pipe installed within the concrete pipe. The condition of the concrete pipe below the PVC sections is unknown and could be adding low flow cross-connections.

Davy St., Storm - Fractures Multiple

Davy St., Storm - Broken, Soil Visible

Davy St., Storm - Crack Multiple

Platoff St., Storm - Broken

King St., Storm - Defective Tap
