FINAL REPORT

King Street Investigation & Rehabilitation

Water Quality Monitoring Report for Data Collected from 2018 to 2020

Our File: 618025

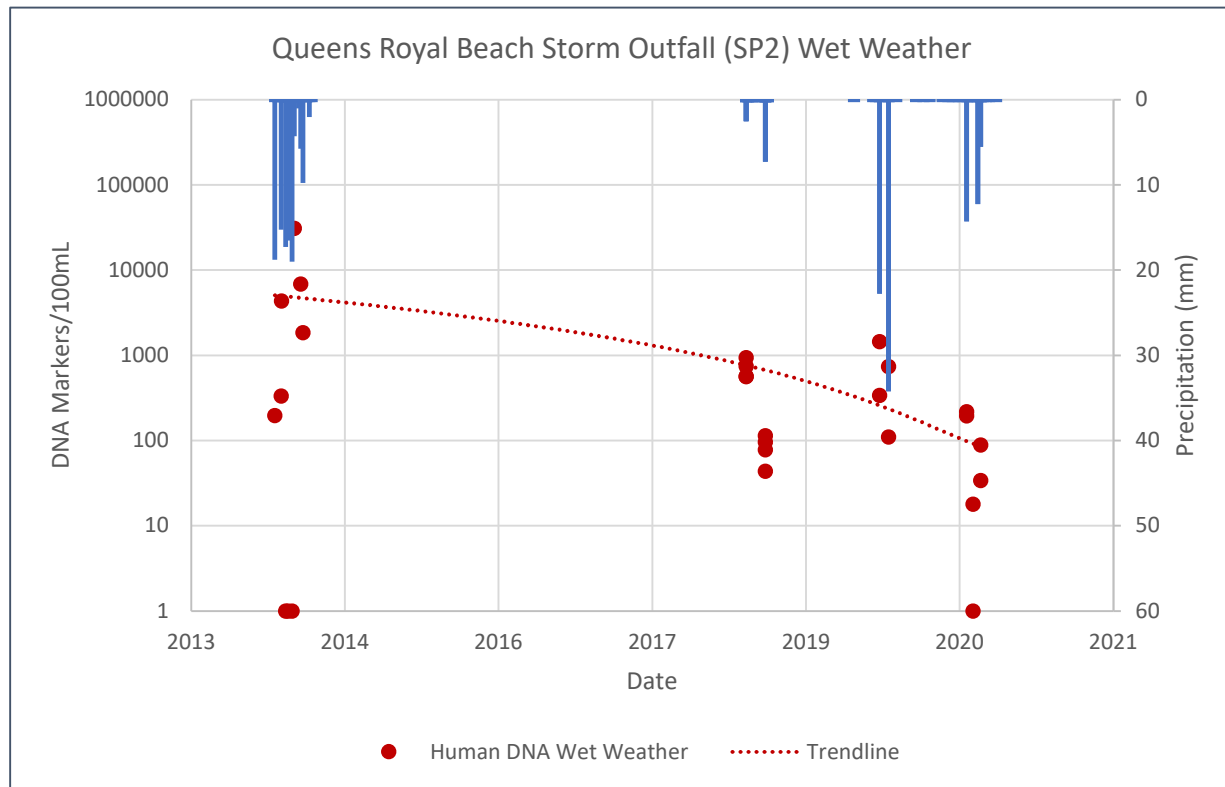
Figure 4: Historical Data for Human DNA marker for KSSO during Wet Weather

The Working Group agreed that the focus for *E. coli* reduction is from human sewage sources as this relates to local issues with sanitary sewer infrastructure and local contamination concerns within the Area of Concern. It should be noted, however, that beach postings from Public Health only account for the amount of *E. coli* colony forming units, not the fecal source of *E. coli*.

The precipitation data is from Niagara Open Data. Rain data for Niagara-on-the-Lake is from the Line 2 Precipitation Station, located within 5 km of the King Street project area. In **Figure 4**, the displayed precipitation (in millimeters) is a summation of all the rain that fell within a 24-hour period of each wet weather sampling day. This is intended to show the correlation between high-intensity rain events and high results of Human DNA marker. The 2020 results displayed on the graph only show the post-rehabilitation results. It is apparent that the Human DNA marker is showing lower levels even with larger storm events. While 2020 was generally a dry year, the Human DNA marker was mostly associated with rain events at the KSSO site.

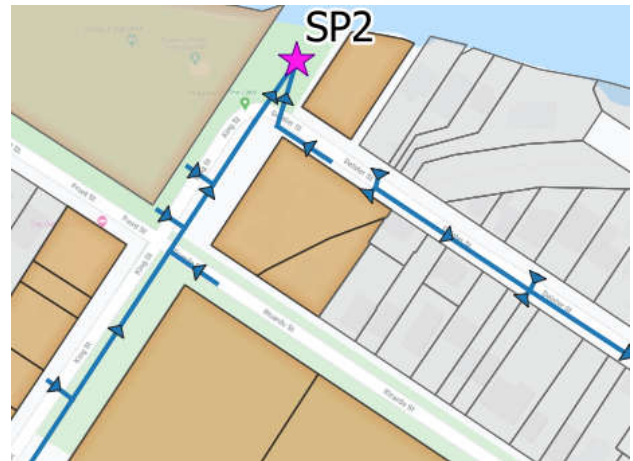
The following summarizes results of the KSSO which discharges near QRB. Results are compared from 2018 to 2020 during both dry and wet weather sampling at Sample Point #2 (SP2).

- Amount of Times No Human DNA marker was Detected at SP2 (Dry Weather) – 100% of samples had Human DNA marker present in 2018. 20% of samples had Human DNA marker present in 2020 resulting in an **80% reduction** in Human DNA marker present at an outlet (SP2) grab sample from 2018 to 2020.
- Historic Monitoring of Human DNA marker at SP2 – **99% reduction** in Human DNA marker level since the highest recorded value in 2014.
- Max Human DNA marker (Dry Weather) – **68% reduction** from 2018 to 2020.
- Max Human DNA marker (Wet Weather) – **85% reduction** from 2019 and **77% reduction** from 2018.
- Max Other Animal Source (non-human and non-gull) *E. coli* (Wet Weather) – **82% reduction** from 2018 to 2020.

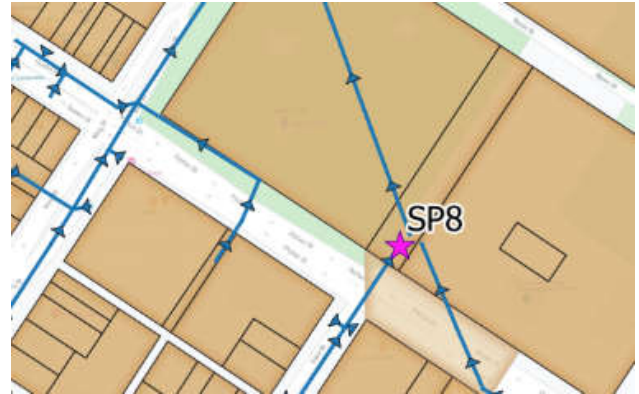
The following section summarizes results of the Davy Street storm sewer, which discharges to Simcoe Park. Davy Street infrastructure improvements occurred in sanitary laterals on private property and owned by the Town and included mainline structural lining of the Davy Street storm sewer. The following analysis compares results from the Davy Street storm sewer point of discharge (SP8) prior to entering the new LID system installed in May 2020 to further improve water quality objectives.

- Amount of times Human DNA marker Detected (Dry Weather) – **100% reduction of Human DNA detected** during dry weather in 2019 and 2020 compared to 2018 when samples always had Human DNA marker present.
- Amount of times Human DNA marker Detected (Wet Weather) – **83% of samples showed no Human DNA in 2020**, compared to 0% (all samples has human DNA detected) in 2018 and 2019.
- Maximum value of Human DNA marker (Dry Weather) – **100% reduction** in Human DNA from 2018 to 2020. Zero Human DNA marker present in 2020 dry weather samples.
- Maximum Other Animal Source (non-human and non-gull) *E. coli* (Dry Weather) – **99.1% reduction** from 2019 to 2020 and **99.9% reduction** from 2018 to 2020.
- Maximum Other Animal Source (non-human and non-gull) *E. coli* value (Wet Weather) – **89% reduction** from 2019 to 2020 and **88% reduction** from 2018 to 2020.

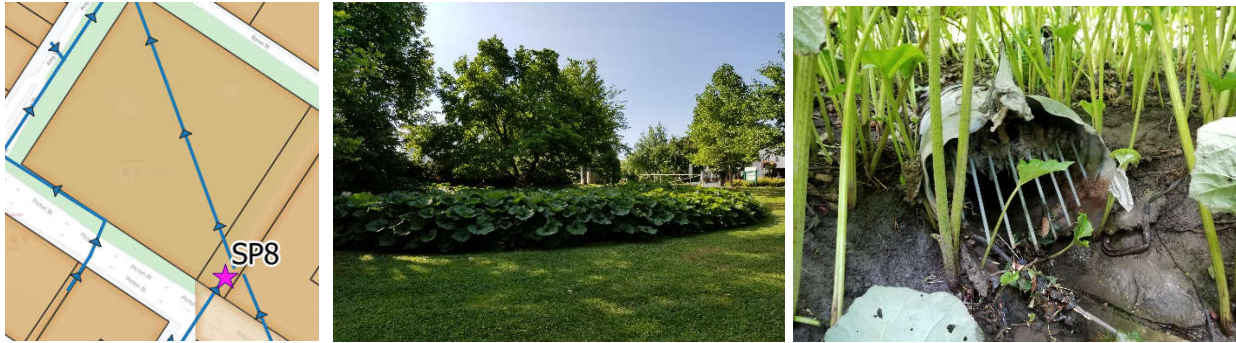
Simcoe Park Before LID

With funding support from ECCC and MECP, a biofiltration LID was designed by GMBP and installation coordinated by the Town within Simcoe Park. The LID construction was completed on May 28, 2020. The biofiltration facility uses one meter of engineered filter media comprised of sand, soil and organic matter to provide quality control treatment for two stormwater outfalls with a 4.2 ha catchment area. Wet weather DNA sampling was completed at the LID site at the inlet and outlet of the LID system to determine the *E. coli* reduction capability.
