Map of Niagara River Area of Concern and its drainage area

Decades of progress to restore the Niagara River's water quality & ecosystem health

History of Lyons Creek

Monitored Natural Recovery Approach

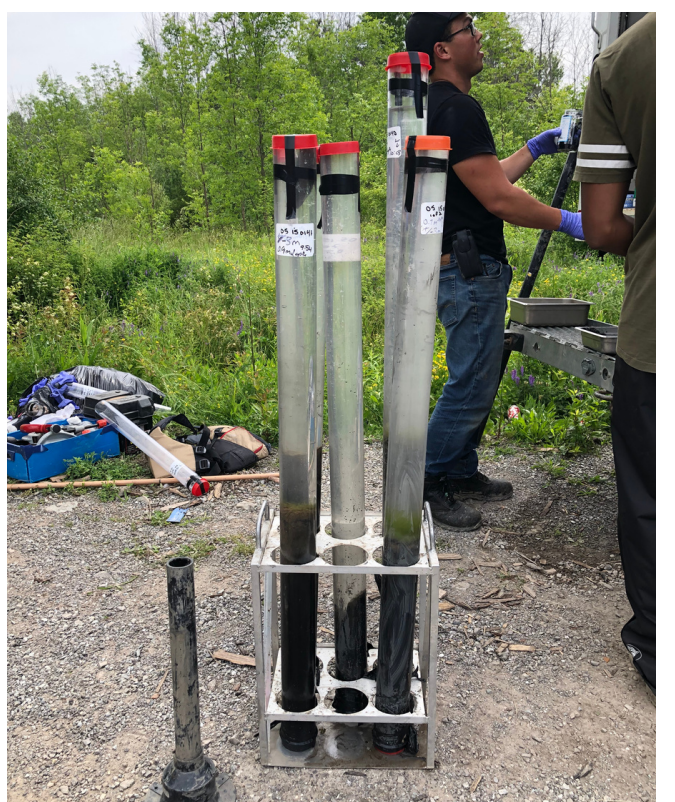
Sediment cores taken from Lyons Creek East for analysis. Note the black colour (PCBs) at the bottom of the cylinder compared to the light brown (cleaner) sediments near the top.
