NIAGARA RIVER AREA OF CONCERN (AOC)

FISH BARRIER PROJECT – March 29, 2010

Fish Population Data Analysis Report

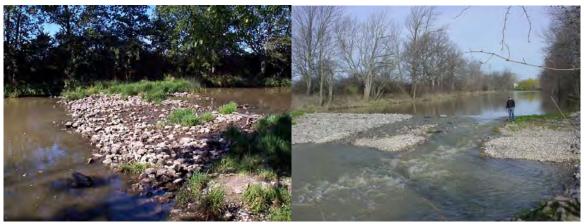
Figure 1&2: FB #3 Before and after remediation.

The Port Davidson Weir on the West Main Welland River was a significant barrier to fish migration due to its extreme slope and composition of large stones, making it impassable to most fish species throughout most of the year. In the winter of 2002/03, river stone was added and a by-pass channel created, with a gentler slope, enabling fish passage throughout most of the year.

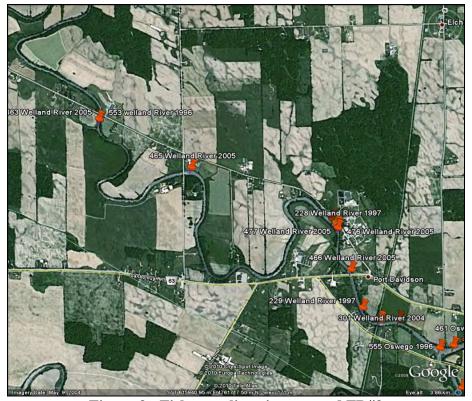
Figure 3: Fish sampling sites around FB#3

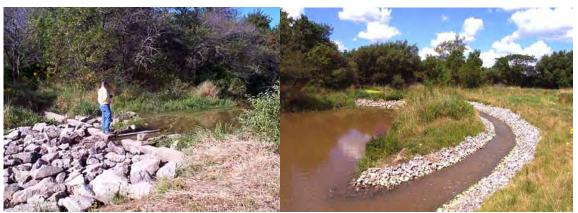
Figure 6&7: FB #4 Before and after remediation.

The Canborough Weir, located on Oswego Creek was remediated in the winter 2002/03. Since the complete removal of the weir was not practical, a by-pass channel with a gentle slope was installed to permit fish passage over their weir. A radio telemetry study, where Northern Pike were tagged with radio transmitters, confirmed that they were able to pass the weir via the by-pass channel.

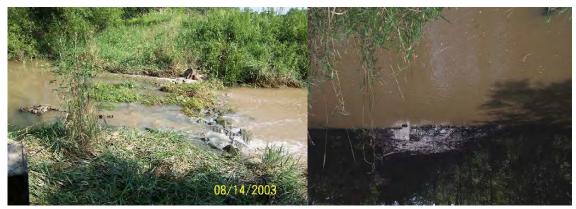
Figure 12&13: FB #16 Before and after remediation.

The landowner was no longer using this former crossing, located in the West Main Watershed. As a result, the crossing was completely removed in 2003/04, returning the stream to its natural flow.

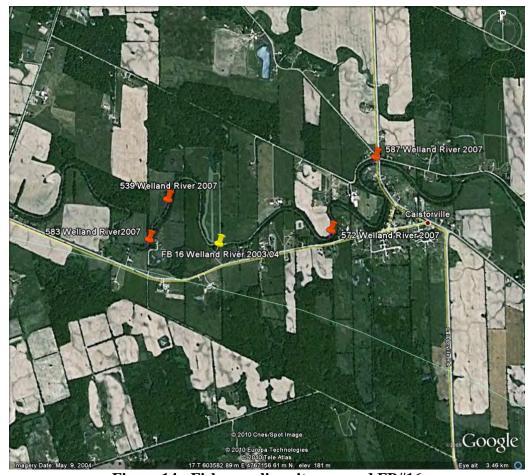
Figure 14: Fish sampling sites around FB#16

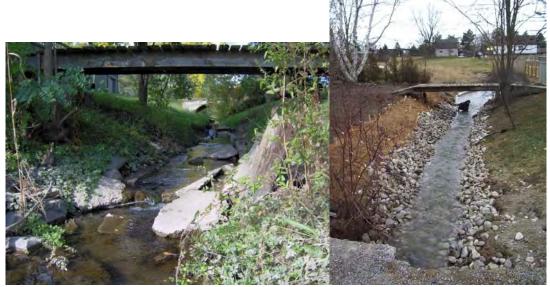
Figure 18&19: FB #28 Before and after remediation.

Over several decades, this portion of Drapers Creek was altered by the installation of concrete debris to stabilize the stream banks. As result, flow was significantly altered and the streambed destroyed. In the winter 2006/07, all debris was removed and replaced with river stone. Bioengineering was then used to stabilize the stream banks with native vegetation.

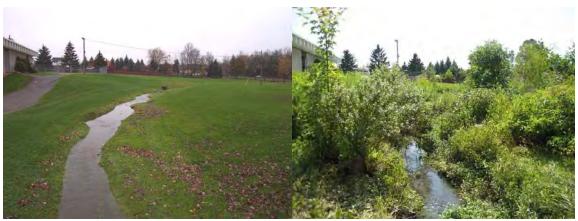
Figure 24&25: Maple Park before and after buffer planting (2004/2009).

In addition to removing barriers to fish migration, the NRC also planted several riparian buffers within municipal parks and golf courses around Niagara. One of the largest buffers planted by the NRC was in Maple Park, which contained a tributary of Drapers Creek. This was part of the Niagara Restoration Council's Building Stream Buffers Project funded by Environment Canada's Great Lakes Sustainability Fund.

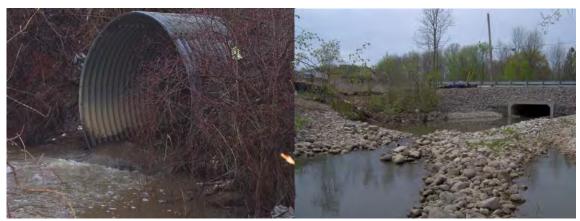
Figure 27&28: FB #34 Before and after remediation.

This perched culvert on Drapers Creek prevented fish migration upstream. In a partnership with the NRC, NPCA, and the City of Welland, the culvert was replaced in 2005/06 with an open bottom concrete box culvert. Additionally, a Newbury riffle was installed with a low-flow channel, using river stone, creating fish 'pools' and essential fish habitat.

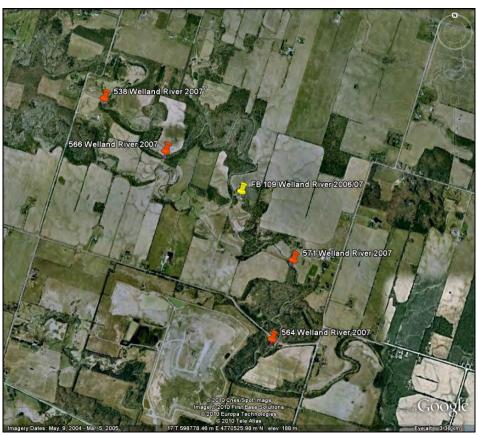
Figure 34: Fish sampling sites around FB#109
