Town of Niagara-On-The-Lake

King Street Investigation

GMBP File: 618025
Draft Submitted: March 2019
Revised: November 2019

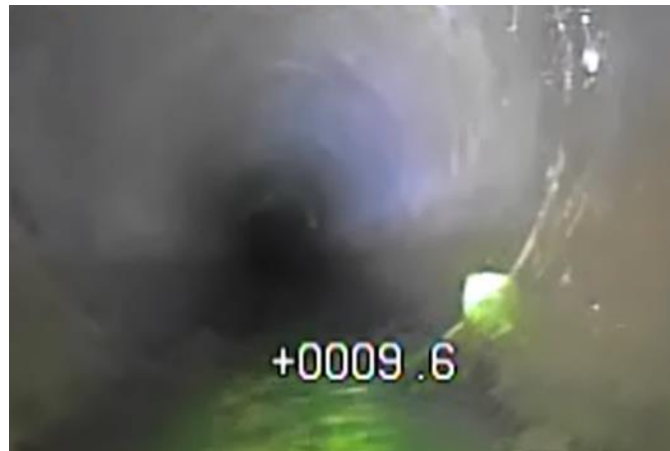
GMBP identified that the majority of Human *E. coli* sources at the KSSO are from low-flow cross-connections. From the background data review, GMBP notes that no sanitary products (toilet paper etc.) have been found in the storm sewer system. The following figure shows a low flow cross-connection between sanitary and storm infrastructure.
